BGA TWS  
1/2/83

Technical Report  
RF 4/5. SERIES.

**Subject:** Damage caused by dampness to the fuselage section and crossbeam of fin on tail unit.

**Concerned:** FOURNIER RF 4, RF 4 D, RF 5 and RF 5 B SPERBER, all Works numbers.

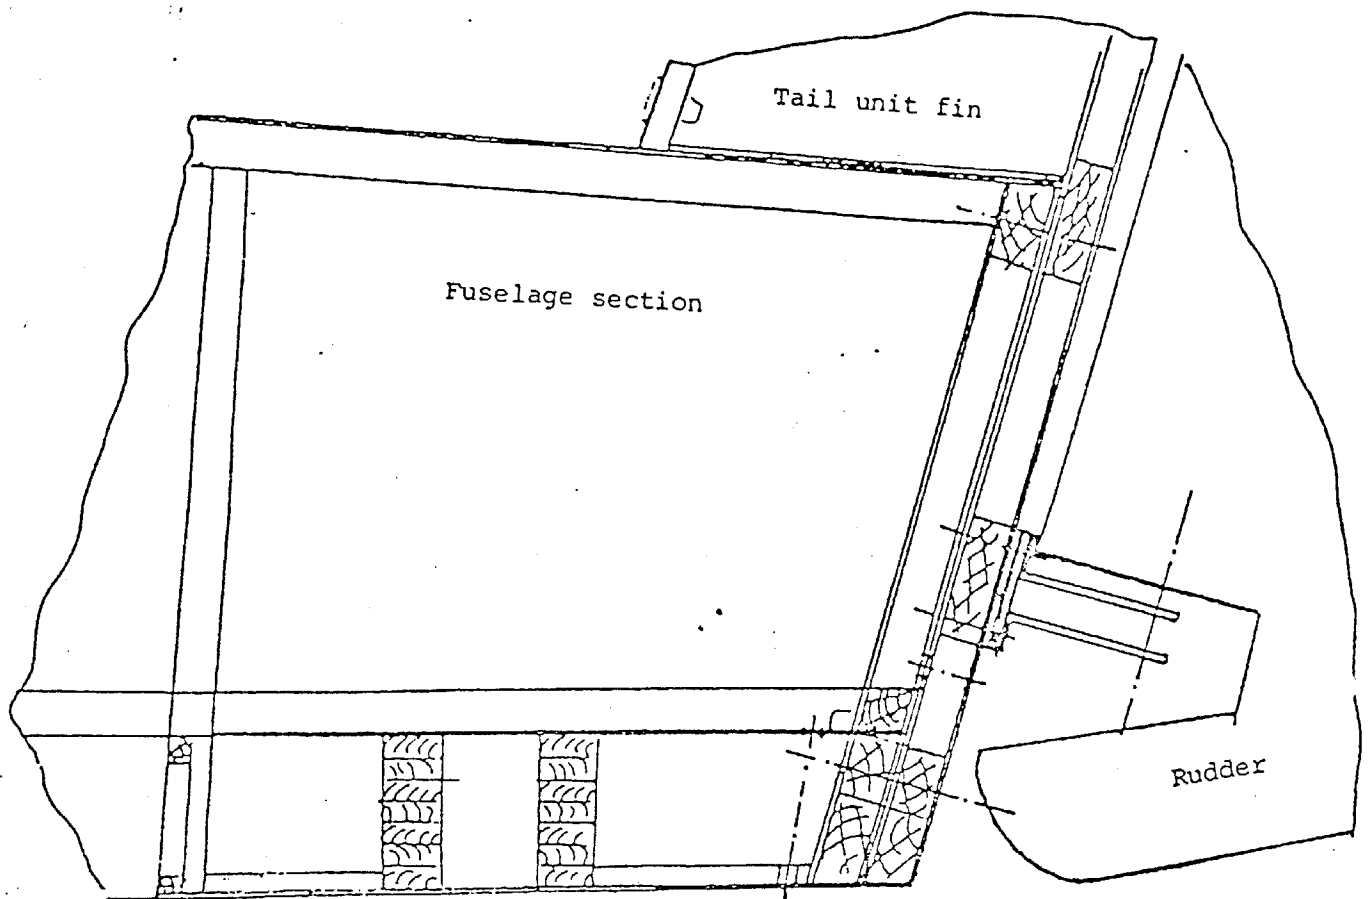
**Course of events:** During a large-scale repair to an RF5 the underside of the fin crossbeam was noticed to be rotting. This rotting was due to the effect of dampness. Presumably water penetrated into the fin crossbeam over the fuselage section and through the drill-hole for the cable to the navigation light.

Drill hole for navigation light.

- 2 Drainage holes in fuselage section bored at the time near the underbrace. Note: Drill holes must pass through the outer casing and the inner floor.

1. Examination of the interior condition of the fuselage for damage to the inner preserving agents and to the plywood parts.
2. Examination of the opening to the drainage hole and the position of the hole in the tail skid. (see sketch). If necessary, new drainage holes should be drilled.

3. If damage to the preserving agents or to the plywood has occurred in the fuselage, and/or the drainage hole is faulty, an examination of the interior condition of the tail unit fin will be necessary. For this purpose, the rudder will be dismantled and the planking of the fin cross beam in the area shown on the sketch will be opened up in a circular area of about 30cm. If no damage to the wood is discovered, the area can be doubled over with 1.5 mm plywood after renewing the interior preserving agent. For this purpose, clean surfaces of varnish and preserving agent and glue on the plywood part(s) with AERODUX 185.
