2. SEVERE TAILPLANE MOUNT BRACKET CORROSION

Aircraft : Fournier RF5  
Date : February 1987

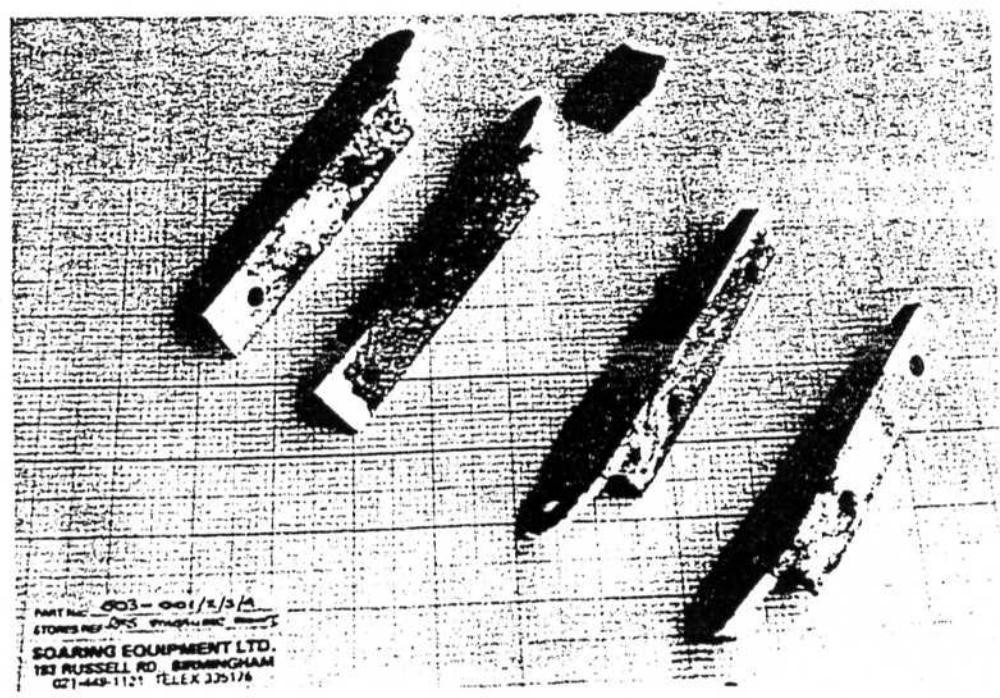
Severe layer type inter-crystalline corrosion was found on all four attachment brackets, one of which has been so badly affected as to reduce the web thickness of the alloy extrusion from 3mm to 1mm, with substantial pieces detached. The Part Nos are 503-001, 002, 003 and 004. It should be noted that only a part of the bracket can be seen even when the tailplane is removed and access must be gained to enable the extrusion within the tailplane to be checked. The worst corrosion is on the face in contact with the wood. The reporter strongly suggests that the parts be removed and inspected for corrosion, as a visual inspection without disassembly may not show the problem. Two similar cases have been reported previously and a Service Bulletin S-01-85 was sent to all RF5 owners on the UK Register in October 1986 by Soaring Equipment Limited.

The most recently found case was on a 4100 hour aircraft manufactured in 1970 which had flown 82 hours since its last annual inspection in April 1986.

CAA Comment:  
All owners should check for this serious fault. The tailplane attachment brackets on the RF4 and RF5B should be of steel and therefore not affected by this problem.
